UNITED STATES DISTRICT COURT
EASTERN DISTRICT OF NEW YORK

Case No. 1:21-CV-3703-HG

RULE 56.1 STATEMENT

PROKRAFT INC. and PRO-CUT,

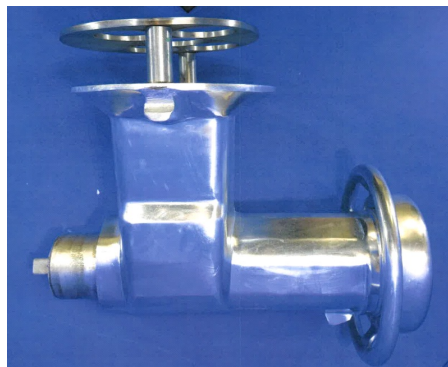
9. As depicted in the photo, the KG-32 Meat Grinder "was equipped with [a] safety guard from the manufacture" which was not a removable device. As depicted in the the photograph, the 'safety guard' is the round apparatus with circular holes located at the top of the photograph.

10. Removal of the safety guard would have to be done with significant force. Eduardo Flores observed a challenge at a trade show where a participant attempted to show that he was strong enough to break the safety guard off of the meat grinder. He was unsuccessful. See, Ex. C, E. Flores dep. tr. at 170.

37. Khusen was working the day the subject grinder was delivered to the store in a box. Id. at 40. He was involved in the unpacking and setup of this grinder. Id. at 41-42. When it was installed in its location, the guard was in place. Id. at 43-44. The guard was “pinned or welded” to the grinder, there were no screws. Id. at 51-52.

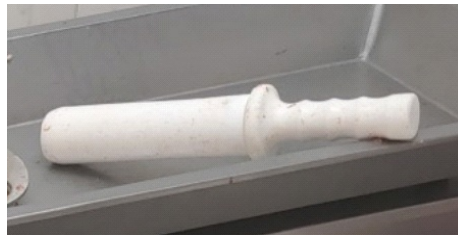
11. The KG-32 Meat Grinder also came with a ‘plunger,’ the purpose of which was to push meat into the machine and thus keep machine’s operator’s hand away from the head stock opening. Ex. D, at 164. An exemplar of the ‘plunger’ which came with the KG-32 Meat Grinder is reproduced below.

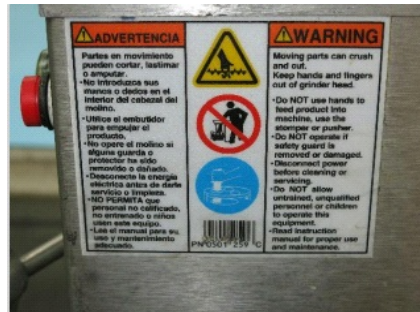
23. The photocopy of a photograph marked as Defendant's Exhibit "C" is an exemplar of the warning label which is affixed to the subject meat grinder. See, Ex. F, at 74-75. For the Court's convenience, the above-referenced photographic evidence is reproduced below.

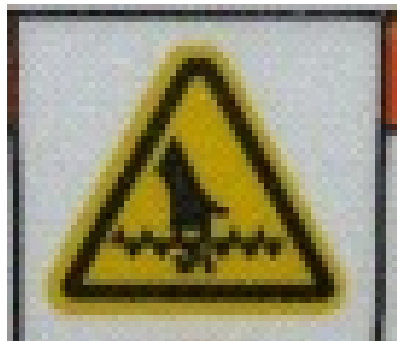
24. Plaintiff confirmed that the exemplar of the warning label that was affixed to the subject meat grinder on the date of incident had a pictogram consisting of triangle within which, in his own words, was a "hand with fingertips cut off." *Id.* at 75. For the Court's convenience, the above-referenced photographic evidence is reproduced below.

45. Khusen was shown the warning sticker on the machine and agreed that the "triangle that was present on the machine, that means don't put your hand near the machine or you might lose your fingers." See, Khusen N.H.'s 5-18-22 dep. tr., **Exhibit "J"**, at 12.

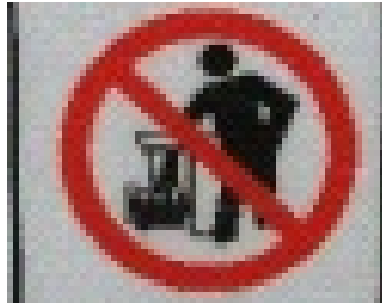
25. With relation to the second pictogram on the above-referenced warning label exemplar, when asked if “[t]he symbol of that figure, putting his hands inside a container,” looked like “somebody putting their hands inside a meat grinder,” Khusenov answered “[n]o,” and testified that he believed this pictogram to depict “somebody putting garbage in a trash can.” Id. at 93-94. For the Court’s convenience, the above-referenced photographic evidence is reproduced below.

46. Likewise, the red circle with a red line through meant do not put your finger or hand on it. Id. at 92
